DocumentType Site Assessment Rpt (SAR)

**Site Summary Report
CUMBERLAND COUNTY LANDFILL-WADE GODWIN
ID Number: NONCD0000735
Cumberland, North Carolina**

**Hurricane Recovery Act of 2005
State of North Carolina
State Contract 6010S
MM&A Project Number NCUL103-02**

August 25, 2006

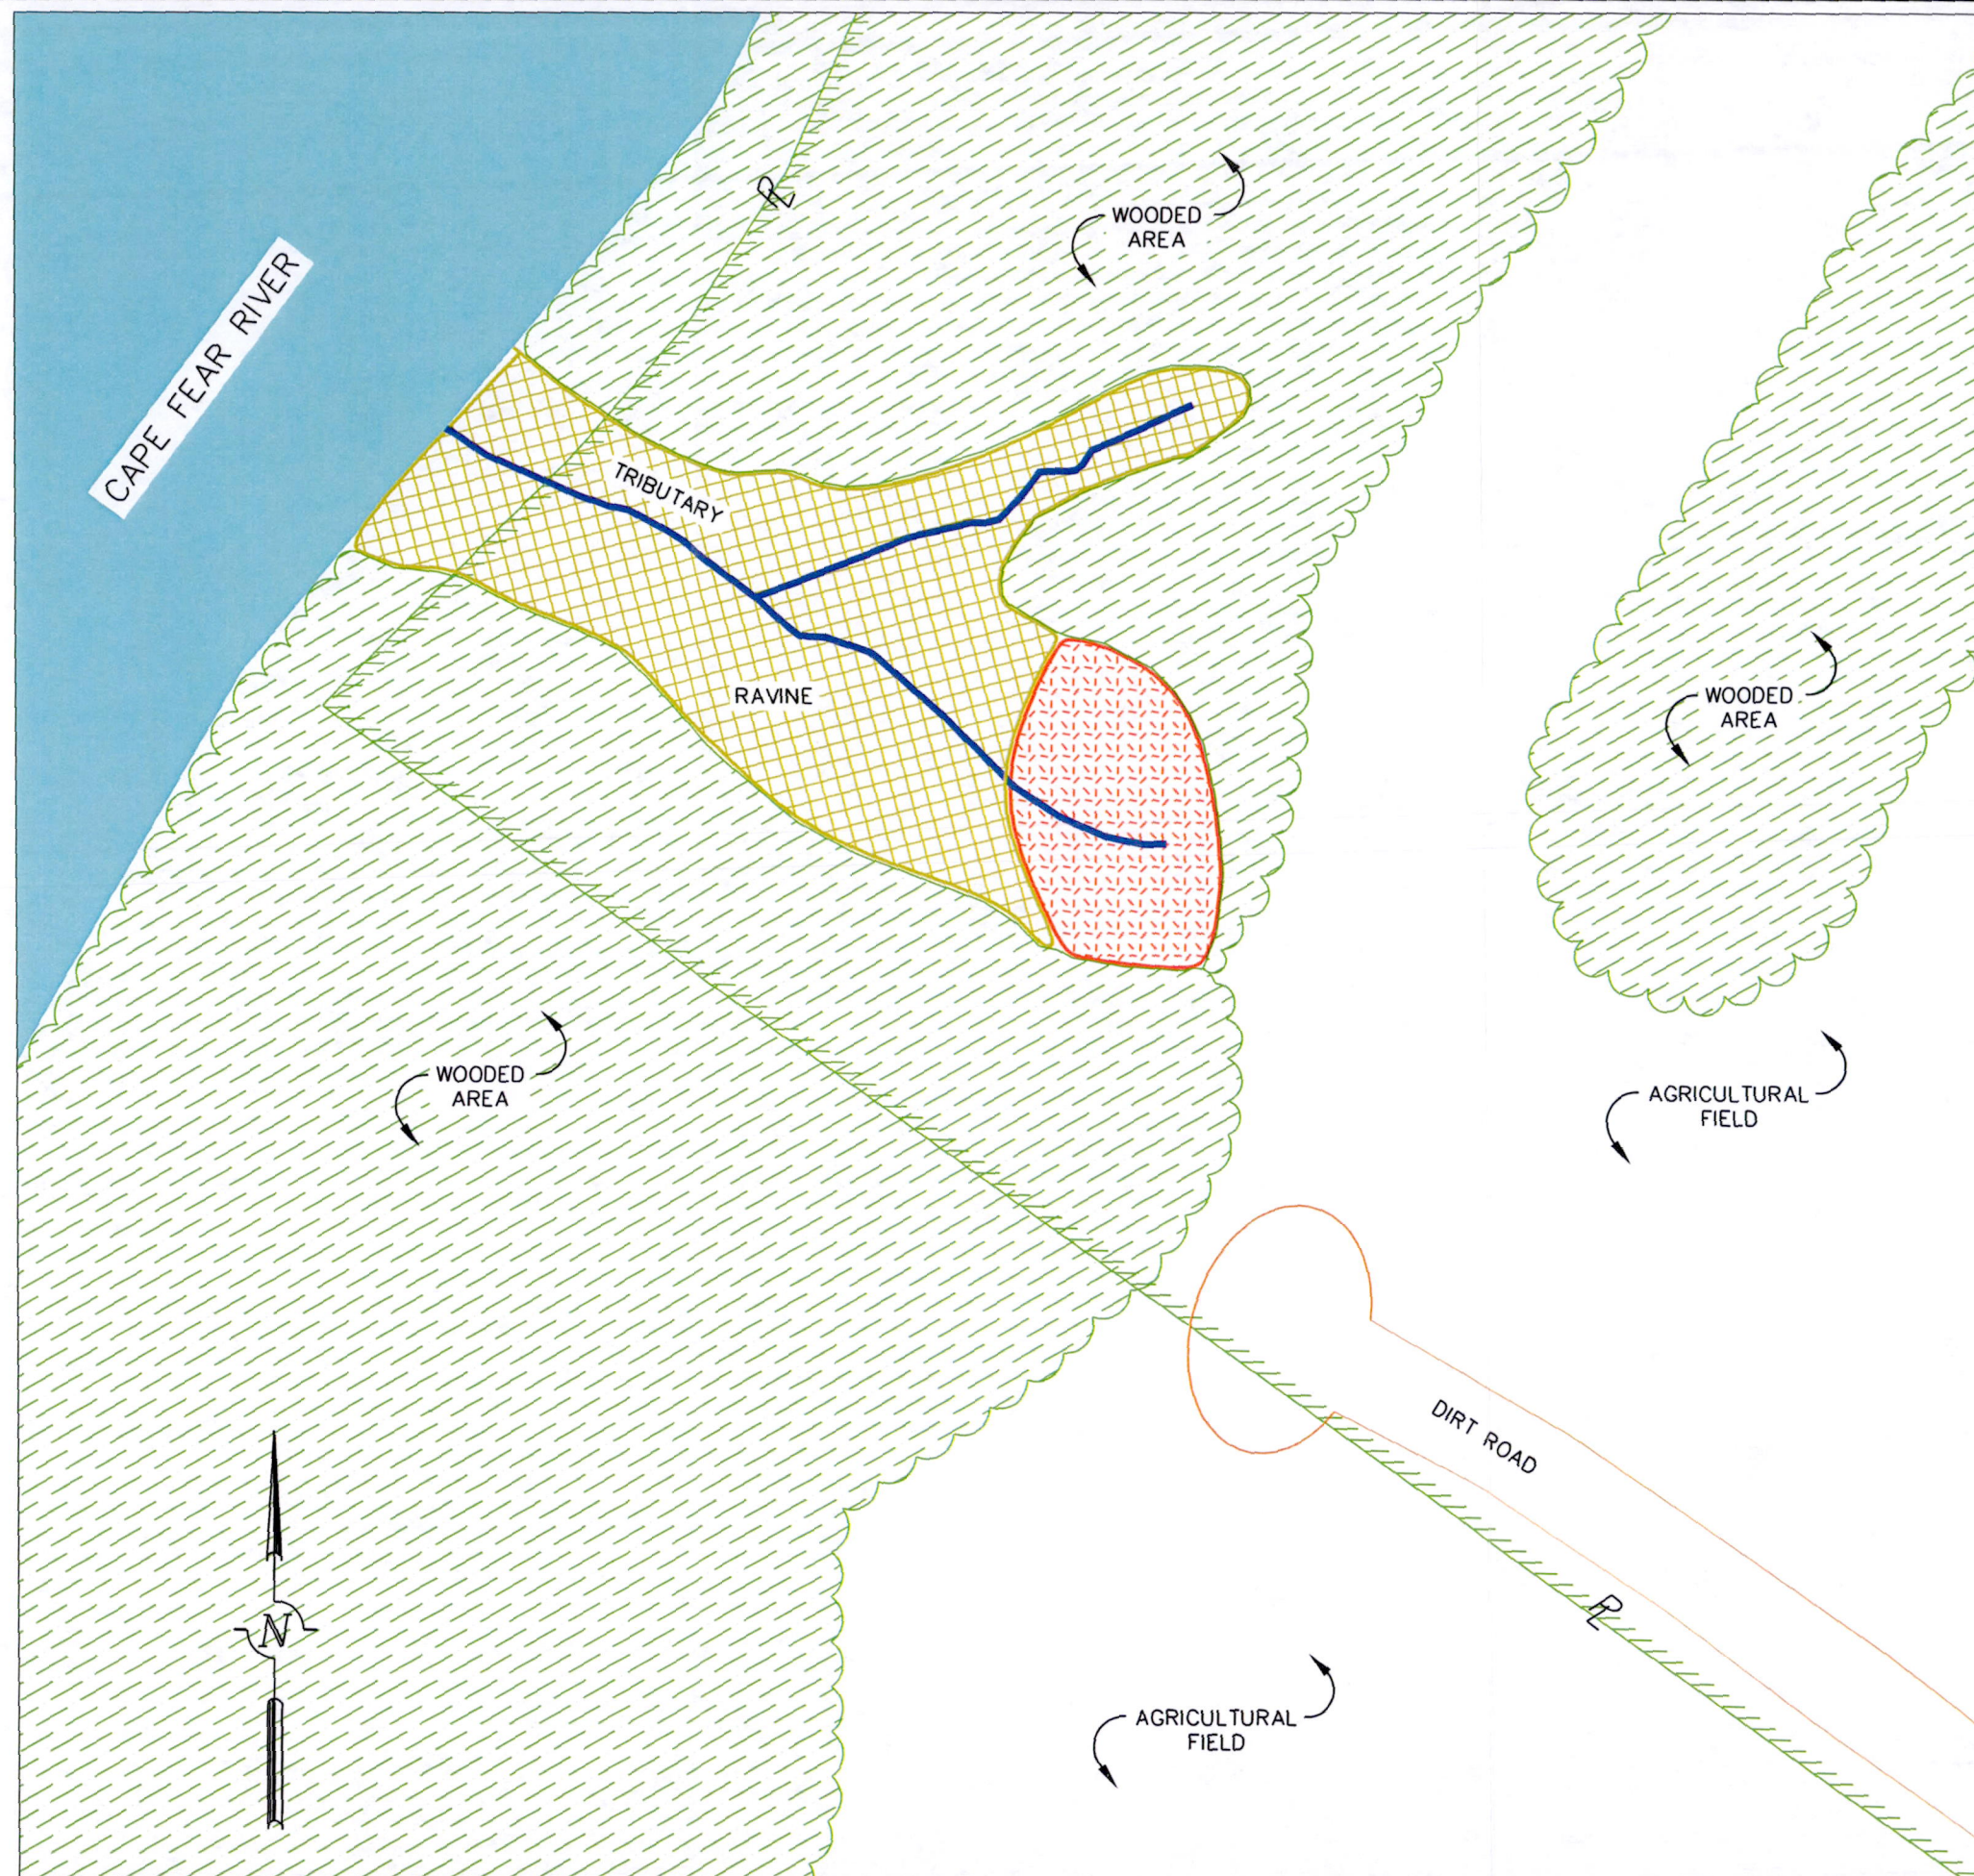
The northeastern boundary of the Site is marked by the Cape Fear River, to which several tributaries and ravines flow. A small stream flows to the south, through the center of the Site, feeding a small pond by the dirt road. **Figure 5** shows the on-site surface water features.

The disposal area is located in a deep ravine approximately 98 feet due north of the terminus of the dirt road that travels the length of the Site. It is covered by thick growth and is not visible from the dirt road. The disposal area occupies approximately 0.09 acres of the 151.41 acre Site based upon GPS mapping of the perimeter, and examination of historical maps and aerial photographs.

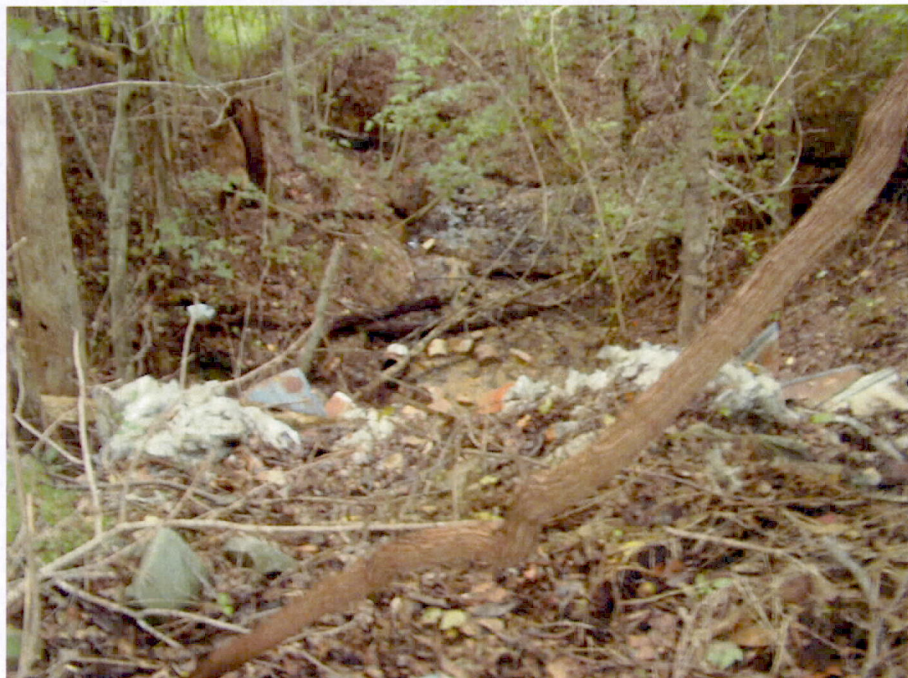
**Description: View
upon entering
disposal area from
field.**

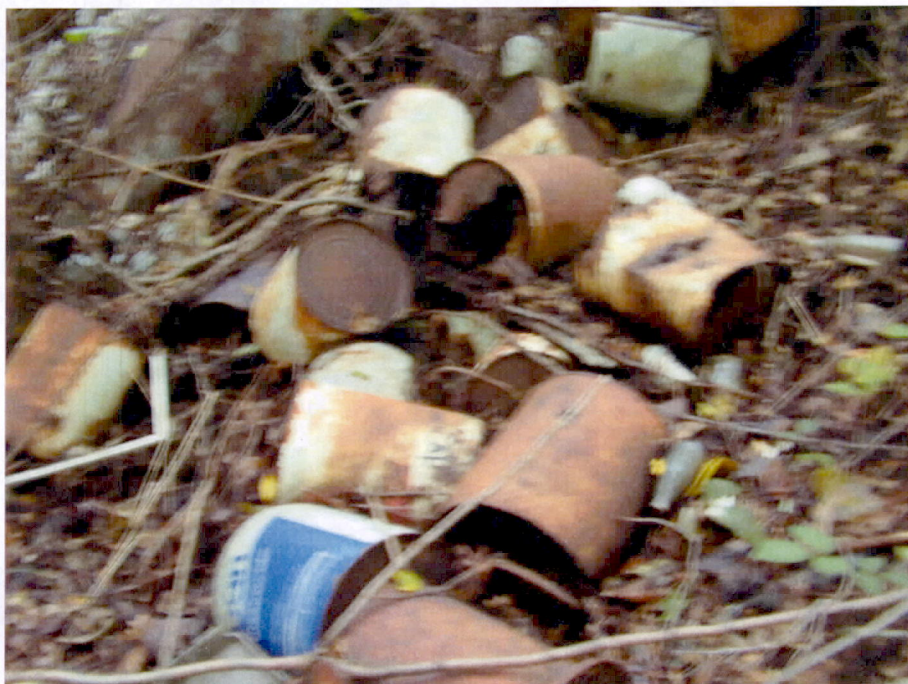
PHOTO 2

During the site visit, as many as 50 discarded five gallon insecticide drums were noted within a ravine and small tributary of the Cape Fear River. The tributary appeared to be spring fed and originates from within the debris pile.

**Description:
Insecticide cans on
south side of ravine.**

RECOMMEND RETURNING TO SITE FOR SOIL AND WATER
SAMPLING TO DETERMINE FURTHER ACTION.

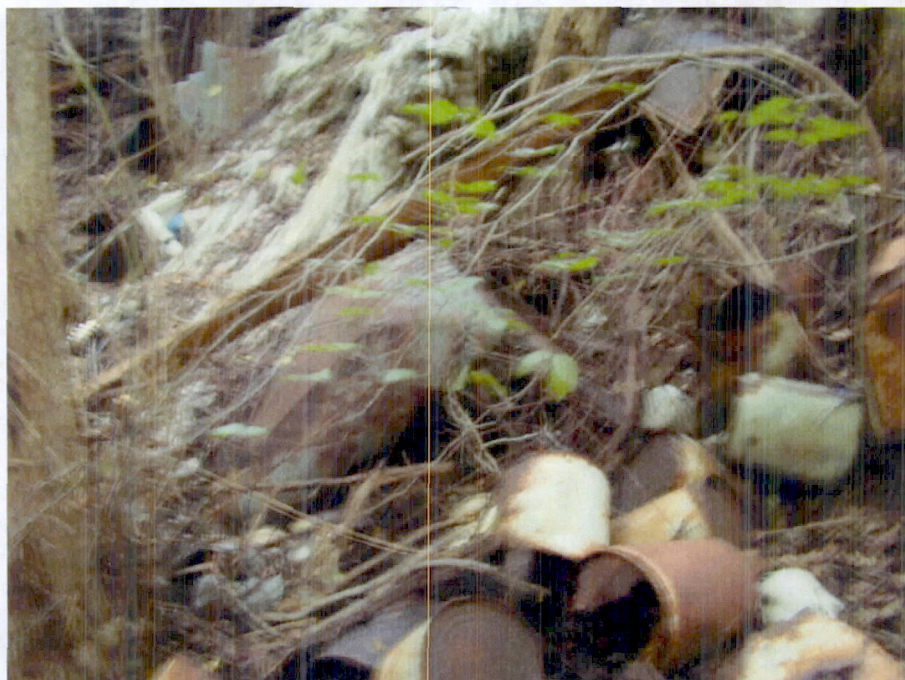
The disposal area does not appear to have been covered. Debris consisting of discarded insecticide cans, concrete, plastic sheeting, metal, and glass can be seen protruding from the walls of the ravine and in the small tributary flowing there through.

**Description:
Construction
debris: plastic
sheeting, fencing.**

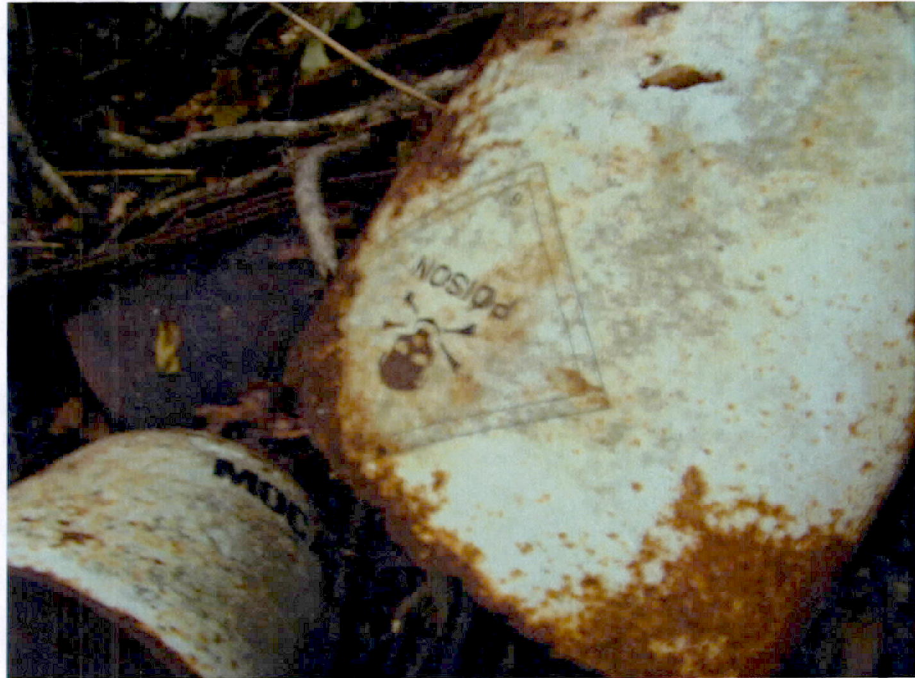
**Description:
Insecticide cans on
hillside.
(close-up)**

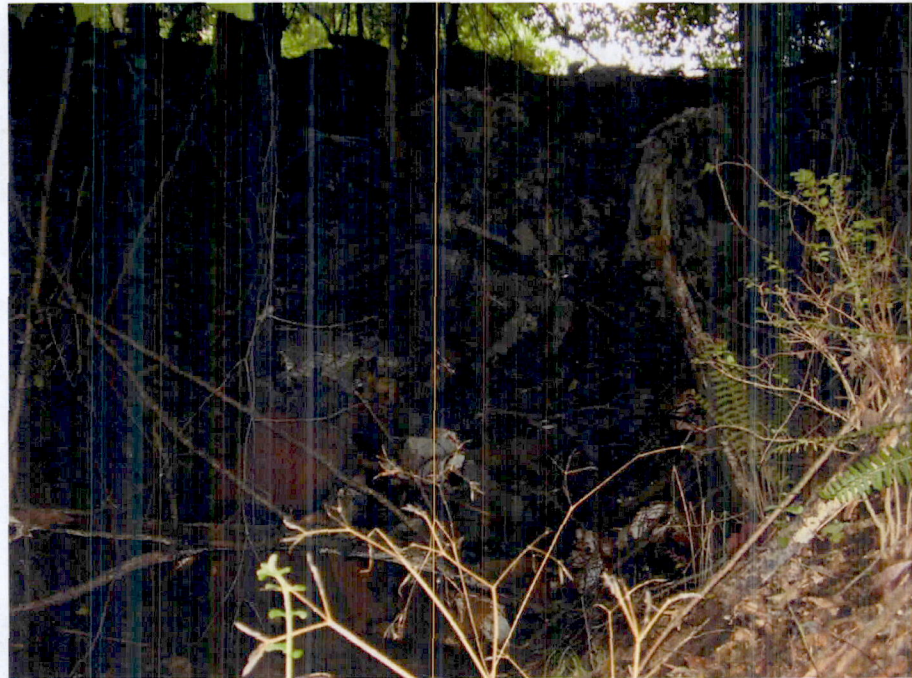
**Description: Top
portion of ravine.**

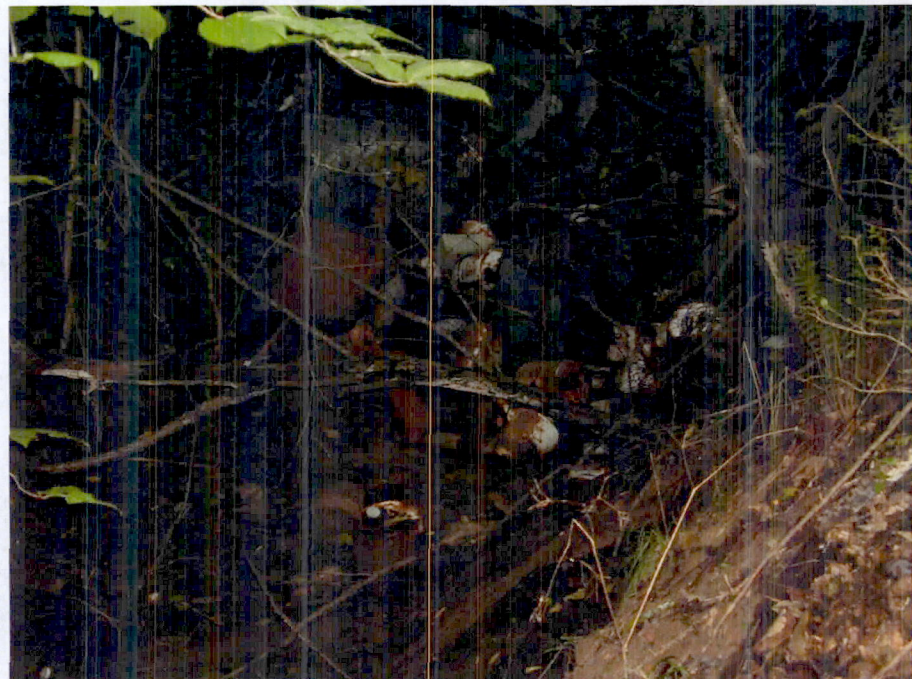
PHOTO 8

**Description: Bottom
portion of ravine.**

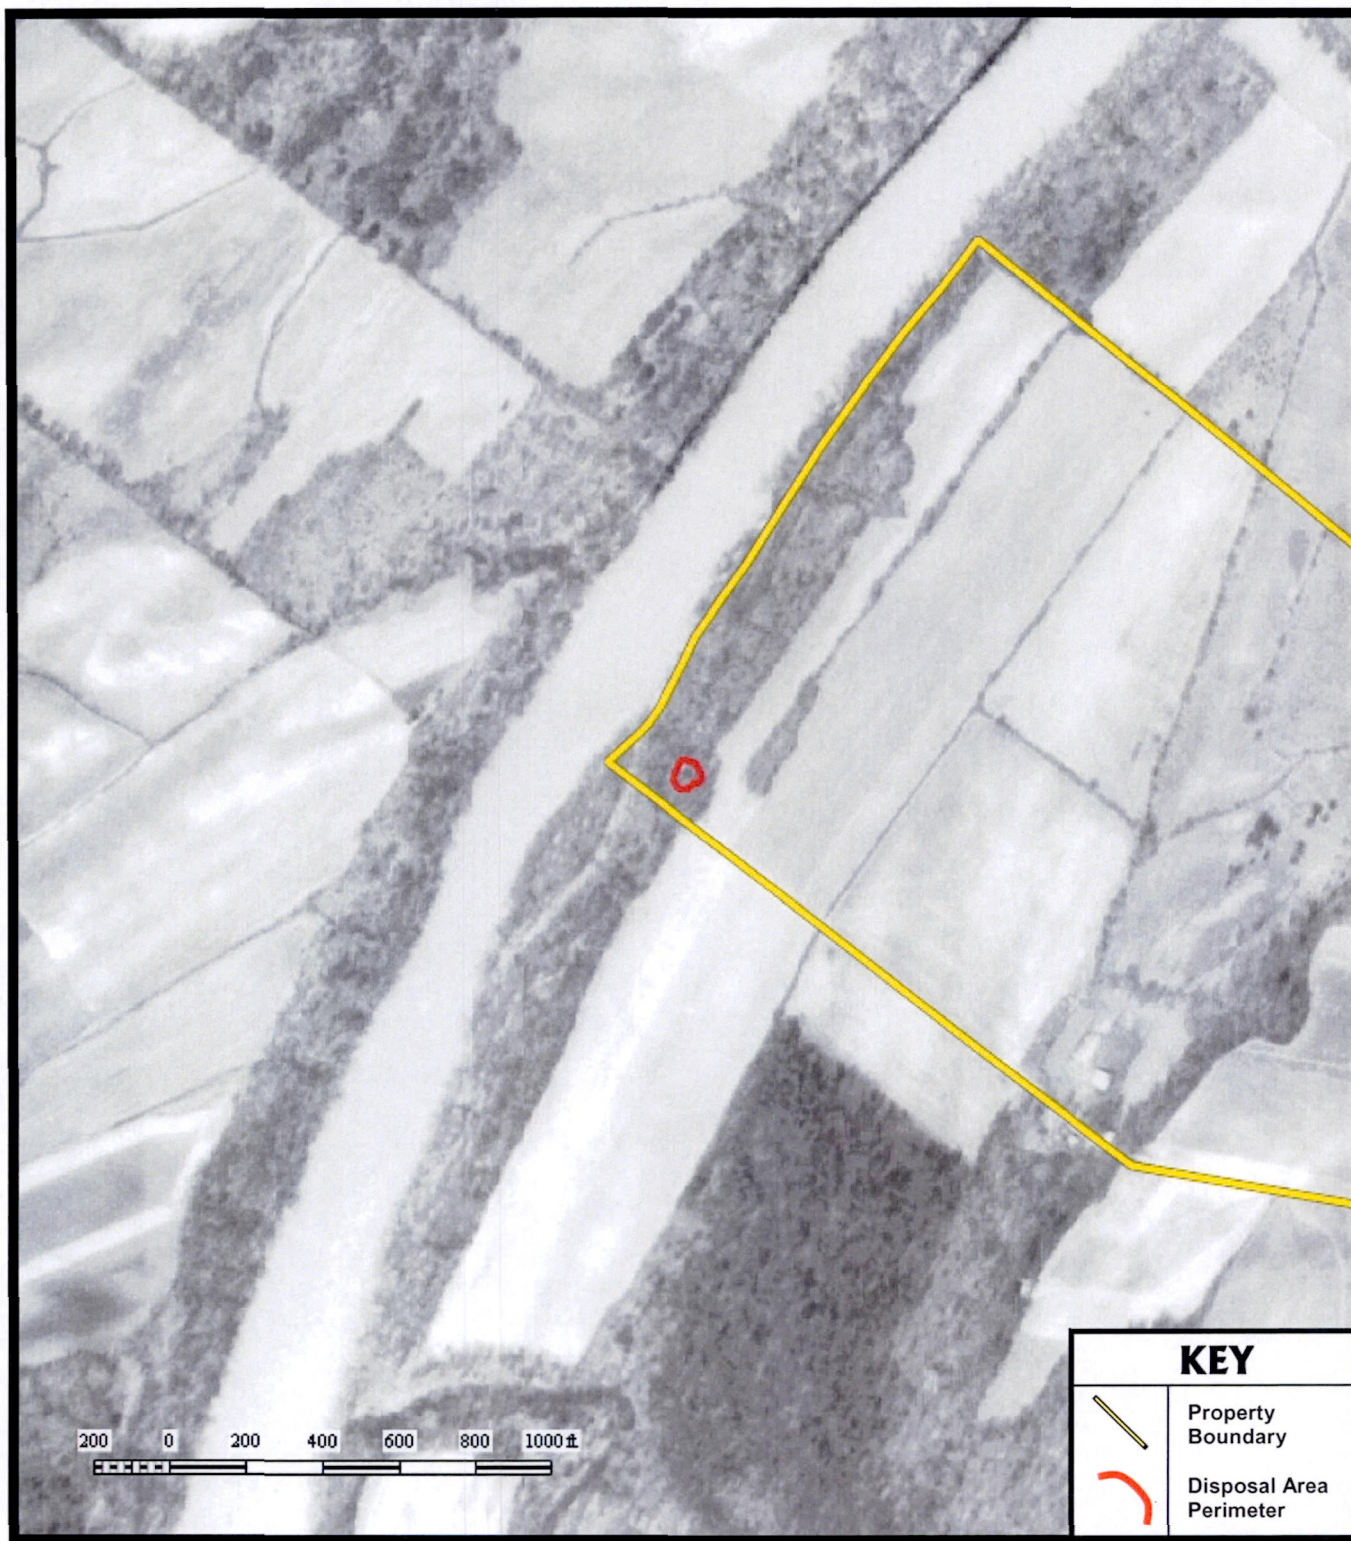
AERIAL PHOTOGRAPH 1960

The 1960 Aerial photograph looks much the same. Slightly more of the Site had been cleared for agriculture and a structure appears to have been erected roughly half way up the dirt road. The dirt road still does not appear to have entered the disposal area. A pond can be seen to the south of the Site, adjacent to Sisk-Culbreth Road.

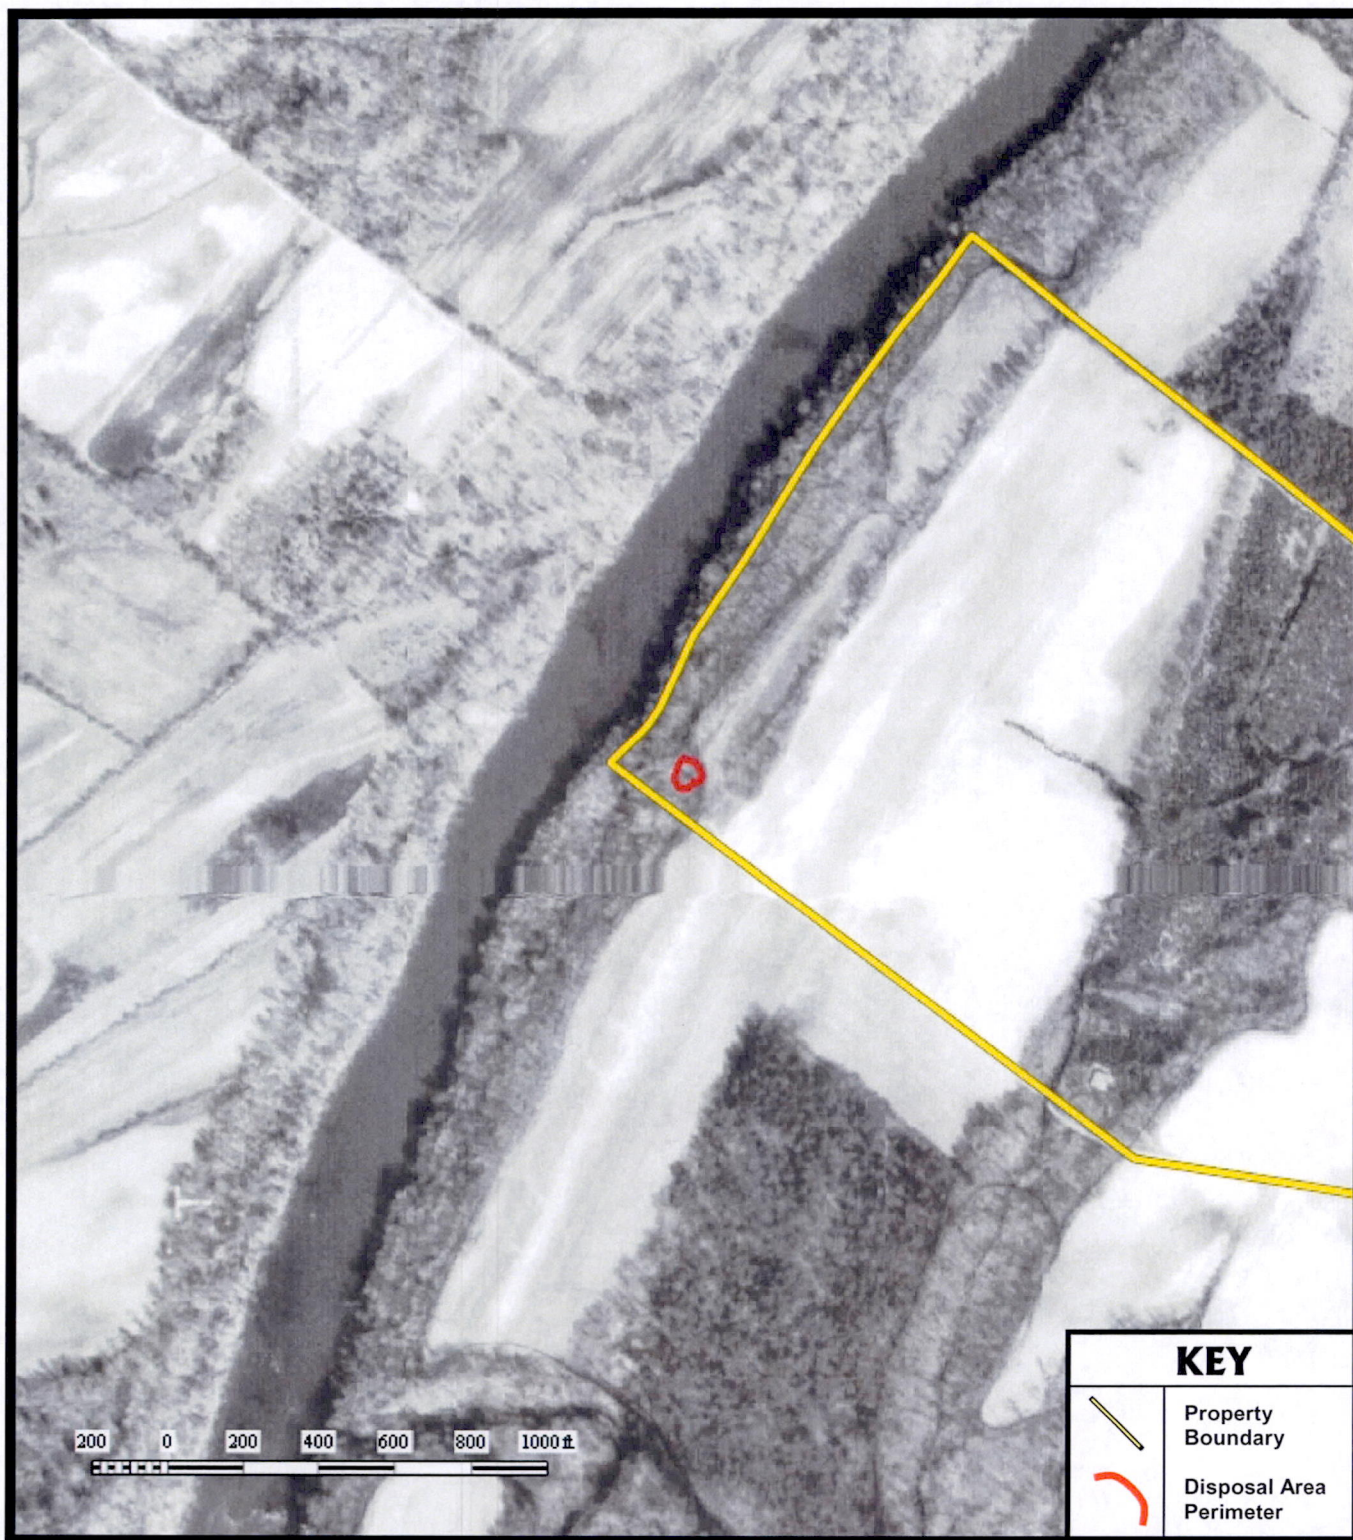
AERIAL PHOTOGRAPH 1972

In the 1972 photograph, it appears that the dirt road was approaching the disposal area, though the disposal area is still not visible through the trees. The surroundings were much that same as in previous photographs and a small pond can be seen on the eastern portion of the Site.

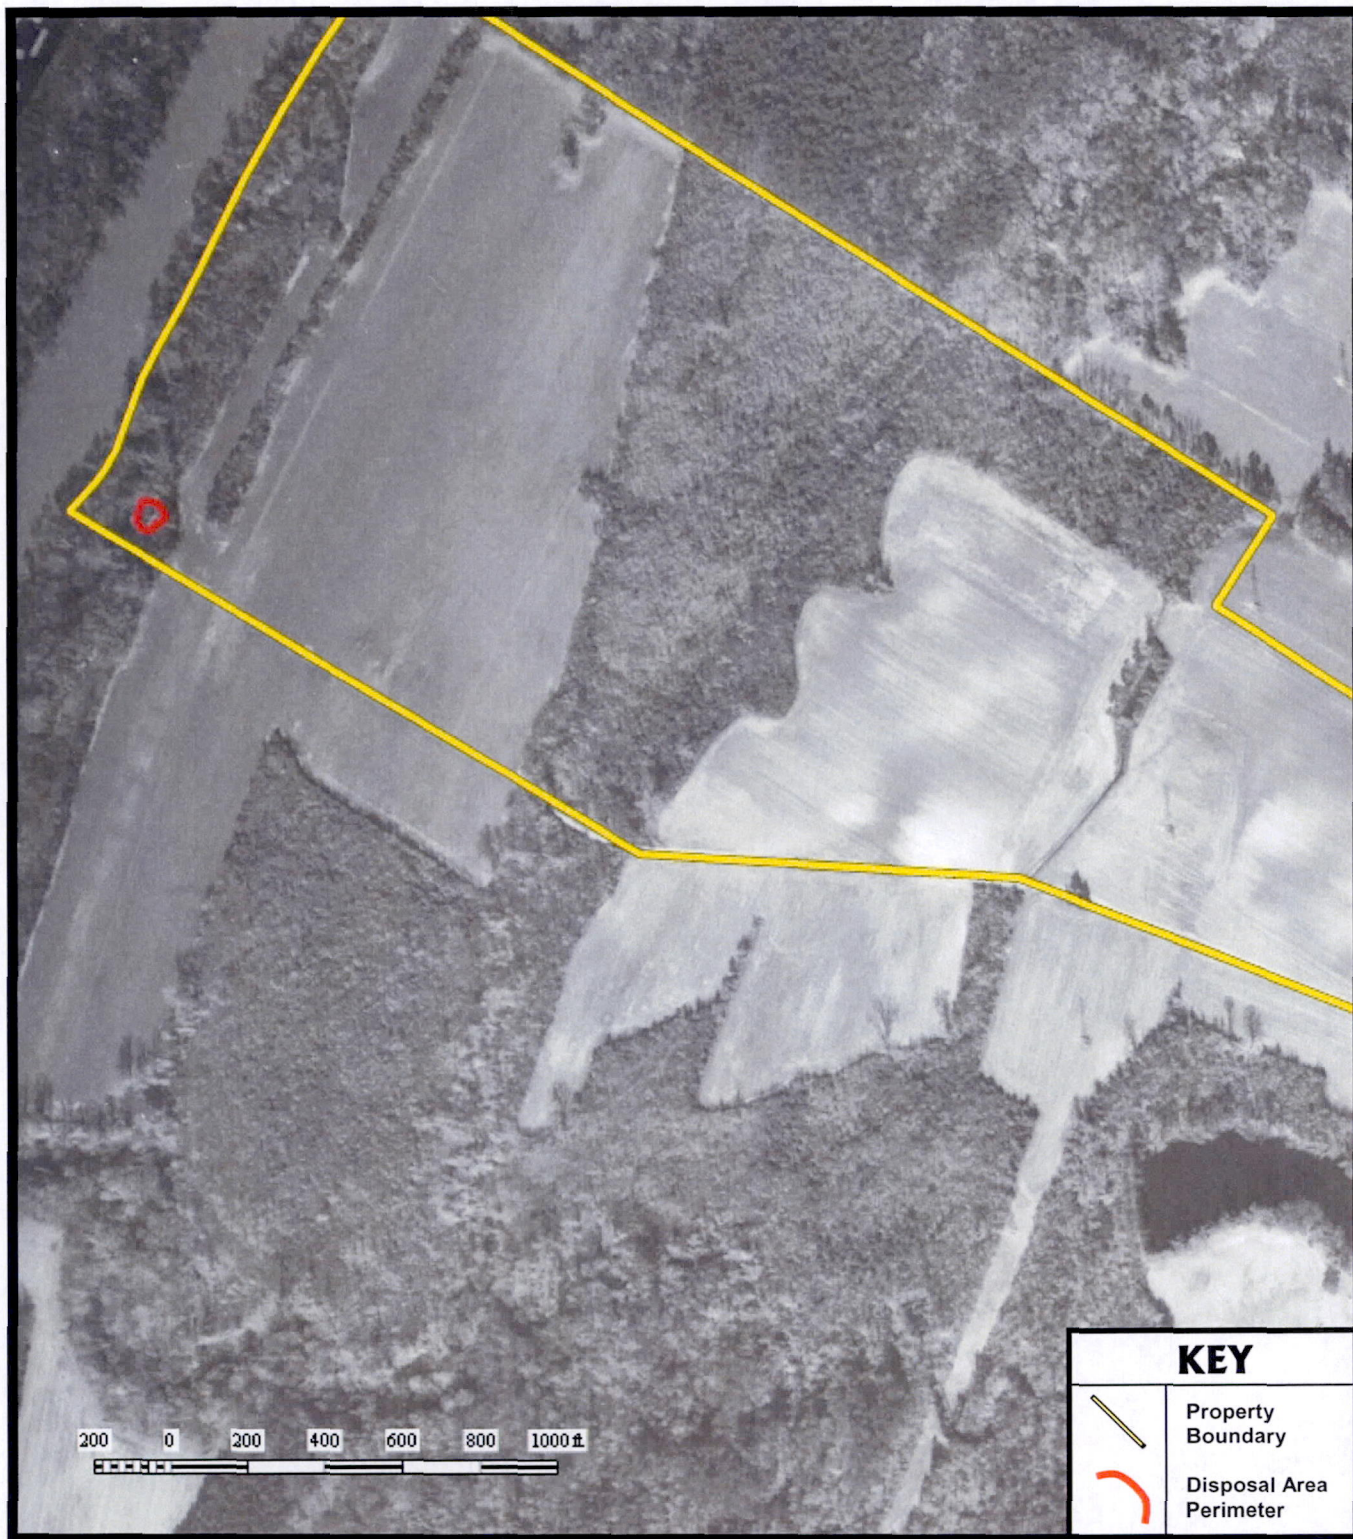
AERIAL PHOTOGRAPH 2002

The 2002 aerial photograph shows that all of the on-site buildings, except for the currently standing storage shed, had been removed. The dirt road appears to have shortened slightly, and no longer approached the disposal area. Throughout the span of the available aerial photograph very little appears to have changed at the Site or in the vicinity. It remained an agricultural area interspersed with wooded land.
